# **COOPERS MILLS DAM, WHITEFIELD, MAINE**

## **CONCEPTUAL REPAIR DESIGN**

**December 2015**

Subject: Conceptual Repair Design for Coopers Mills Dam, Whitefield, Maine

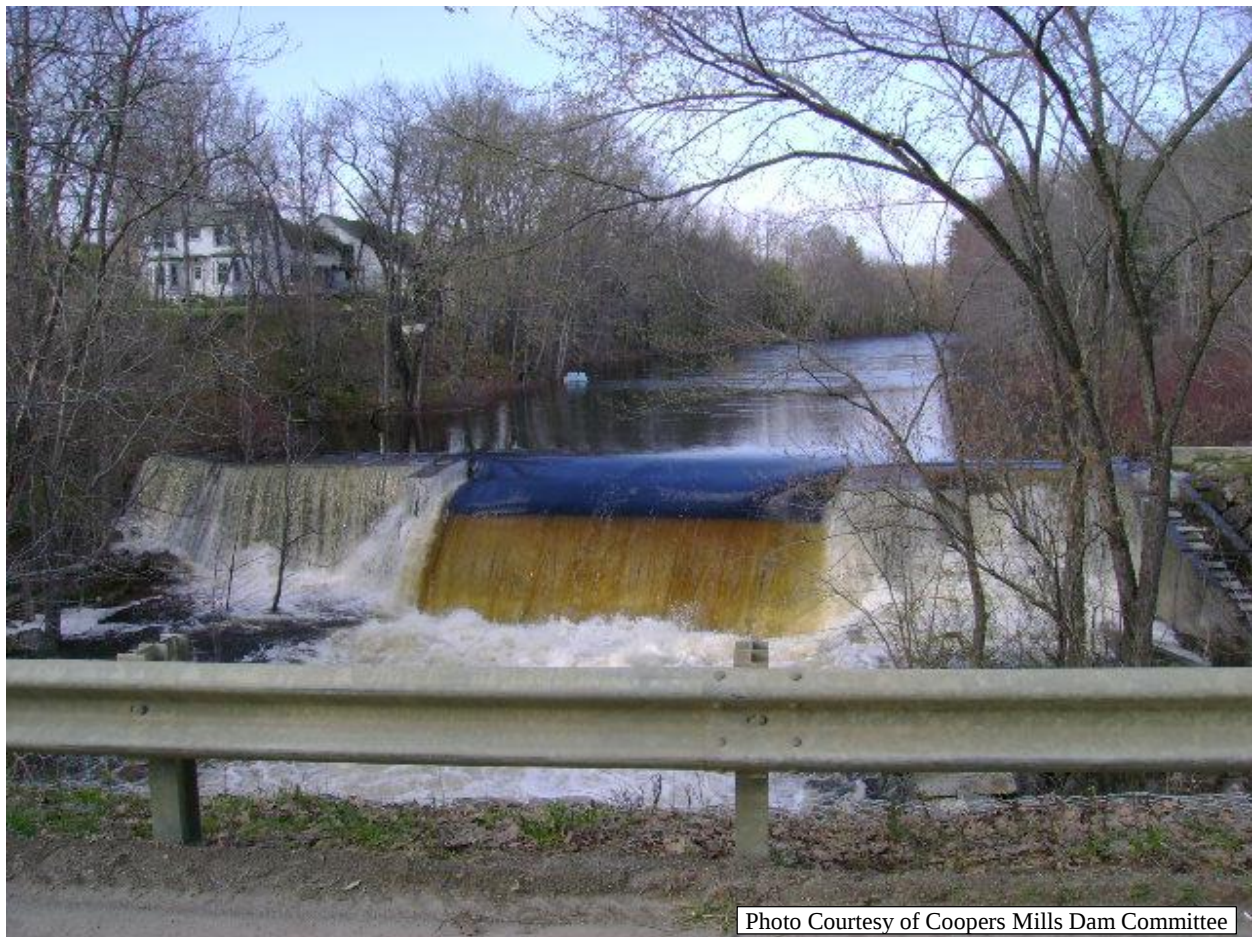
Figure 2. Coopers Mills Dam Overtopping During Spring Runoff, 23 April 2006.

173.2 feet resulting in slight overtopping of the parking lot on the left abutment at the location of the dry fire hydrant by about 0.2 foot (2 ½ inches). Due to the insufficient spillway capacity, it is expected that the dam would be overtopped relatively frequently during the 2-year to 10-year floods. The latest recorded flood of unknown recurrence causing overtopping of the dam occurred in April 2006 and is shown in Figure 2.

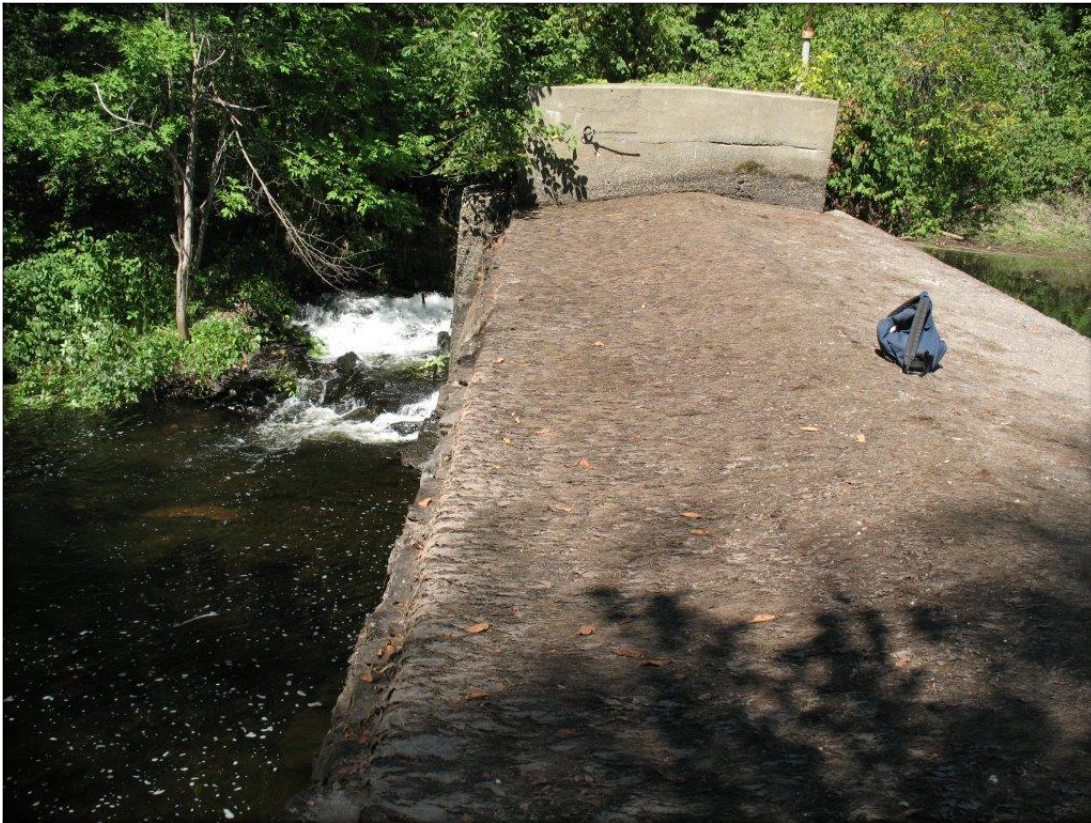
The right spillway pier was in adequate and stable condition (Photo 1). A horizontal crack in the concrete cover located about 2 feet above the spillway crest was slightly eroded but appeared tight. The concrete surface below the crack was moderately weathered exposing concrete aggregate. High watermark imprinted on the pier below the crack indicated that the typical high water level in the pond was about 2 feet above the spillway crest.

Photo 1. Spillway Crest and Right Pier.

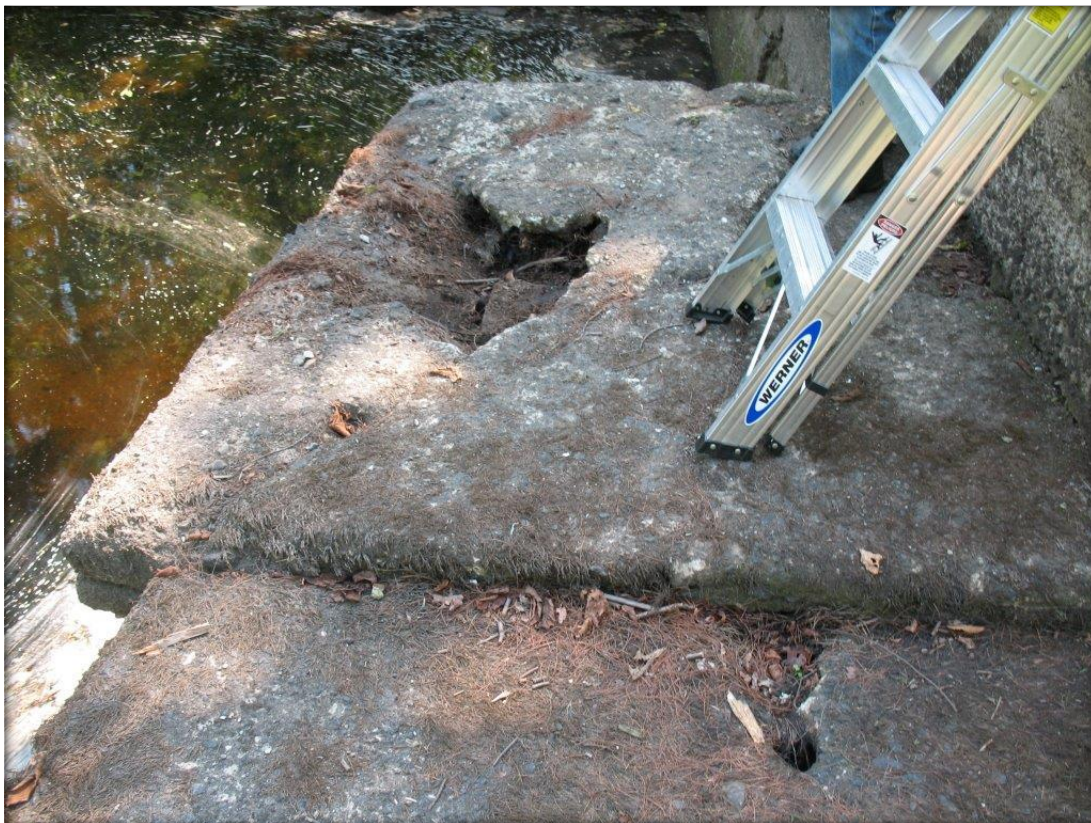
providing a direct entry of the pond water to the masonry interior (Photo 2). It is possible the cavity was formed by the impact from moving heavy logs observed hanging on the spillway during our site visit in 2007. About 4 feet of the upstream spillway face above the pond level available for observation experienced significant deterioration resulting in a loss of about 50 to 70 percent of the concrete cover, missing stone, and development of voids (Photo 3). A large cavity, about 20 feet long, 1 foot high, and up to 12 inches deep was observed under spillway crest concrete overlay (Photo 3). The cavity reduces a bearing support for the concrete cover and provides a potential seepage entry into the structure. The downstream face of the spillway composed of angled, mostly elongated rocks appeared stable and dry for the most part. Leakage emerging from the spillway downstream face at the level about 1.5 feet above the tailwater was confined between the exposed ledge<sup>3</sup> and left spillway corner and then continued along the masonry placed between the spillway and fishway (Photo 4). A leakage discharge at this area was estimated about 10 cubic feet per second (cfs). Some foam circulation indicating presence of considerable leakage was also observed immediately to the right of the exposed ledge.

Photo 2. Large Cavity in Spillway Crest Extension at Left Nonoverflow Structure.

To control leakage, the concrete overlay would be installed on the upstream face of the spillway and left and right nonoverflow structures, the spillway crest would be resurfaced with new concrete overlay, left leaking culvert outlet would be permanently plugged with concrete, and right leaking outlet would be fitted with a new PVC pipe and watertight slide gate. The overlay would also seal the deteriorated surface containing loose masonry, cracks, and voids and protect dam structures from further deterioration. A 10-inch thick reinforced concrete overlay would be anchored to the existing masonry and rock foundation with steel dowels. The overlay would be advanced about 12 inches deep in foundation to isolate a potentially water conveying contact between the dam and its base. The details of the concrete overlay to be placed on the upstream dam face and spillway crest and restoration of the right outlet are shown in Sections 1-3, 7 included in Attachment C.

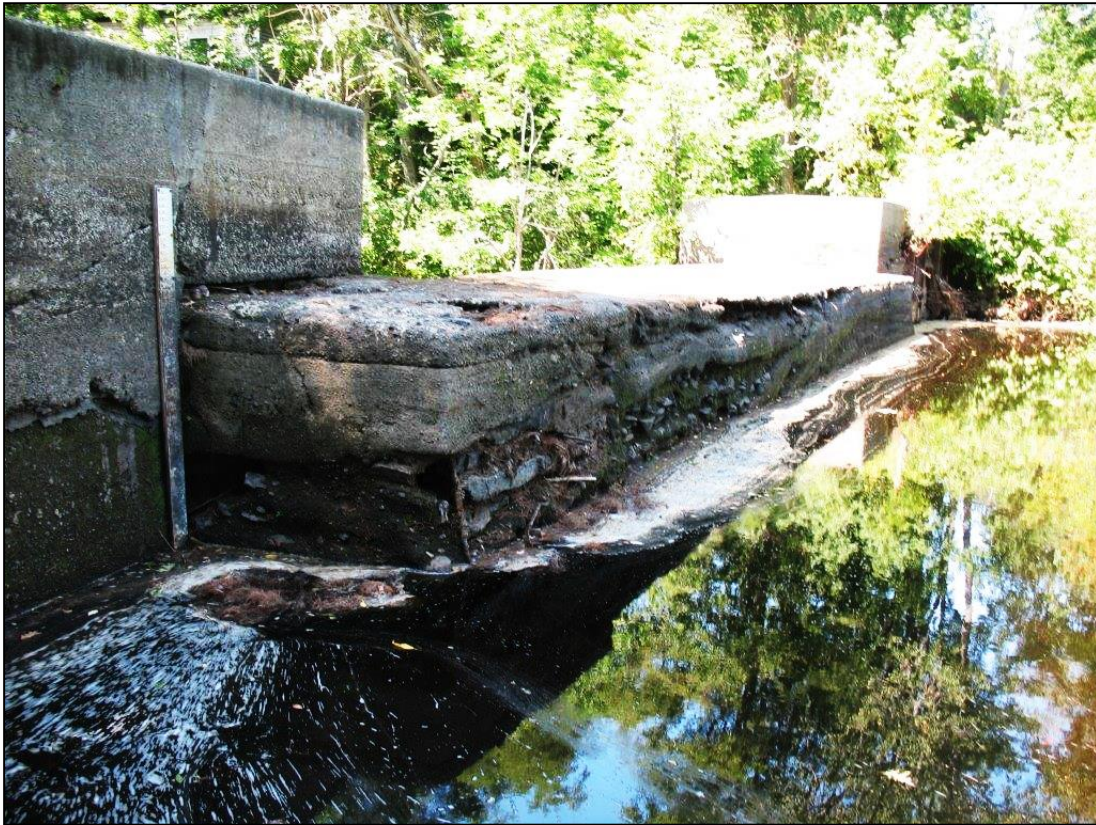
The structure significantly deteriorated over the years but appeared stable. The top of the nonoverflow was in reasonable condition. The upstream face concrete developed a couple of large diagonal cracks (Photo 3). The cracks were moderately eroded and tight. Two large voids and a loss of the concrete cover were observed on the vertical surface of the structure adjacent to the spillway and nonoverflow (Photo 3). The downstream face of the nonoverflow was significantly deteriorated and undermined showing missing masonry, eroded cement grout and significant amount of voids (Photo 8). The downstream fill consisting essentially of cemented gravel, cobbles and rocks was eroded exposing rugged surface likely caused by overtopping. The area was vegetated and contained a large tree growing close to the structure. A massive block adjacent to the fishway and left nonoverflow experienced significant deterioration including missing and displaced masonry and lost concrete cover (Photo 9). The block contained a large cavity, 4 feet high and 2 feet wide, visible on the riverside and downstream faces.

Photo 3. Upstream Face of Spillway and Left Nonoverflow: Note Voids and Deep Deterioration.

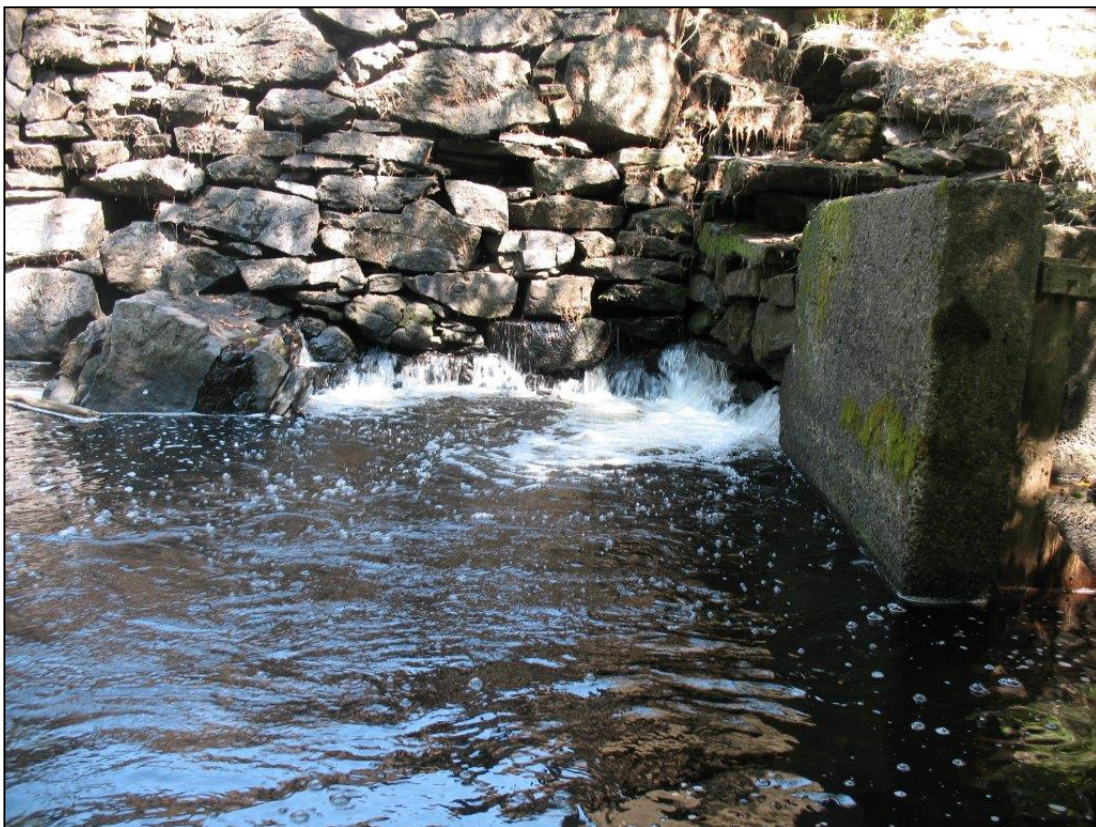
Photo 4. Extensive Leakage at Spillway Toe near Fishway.

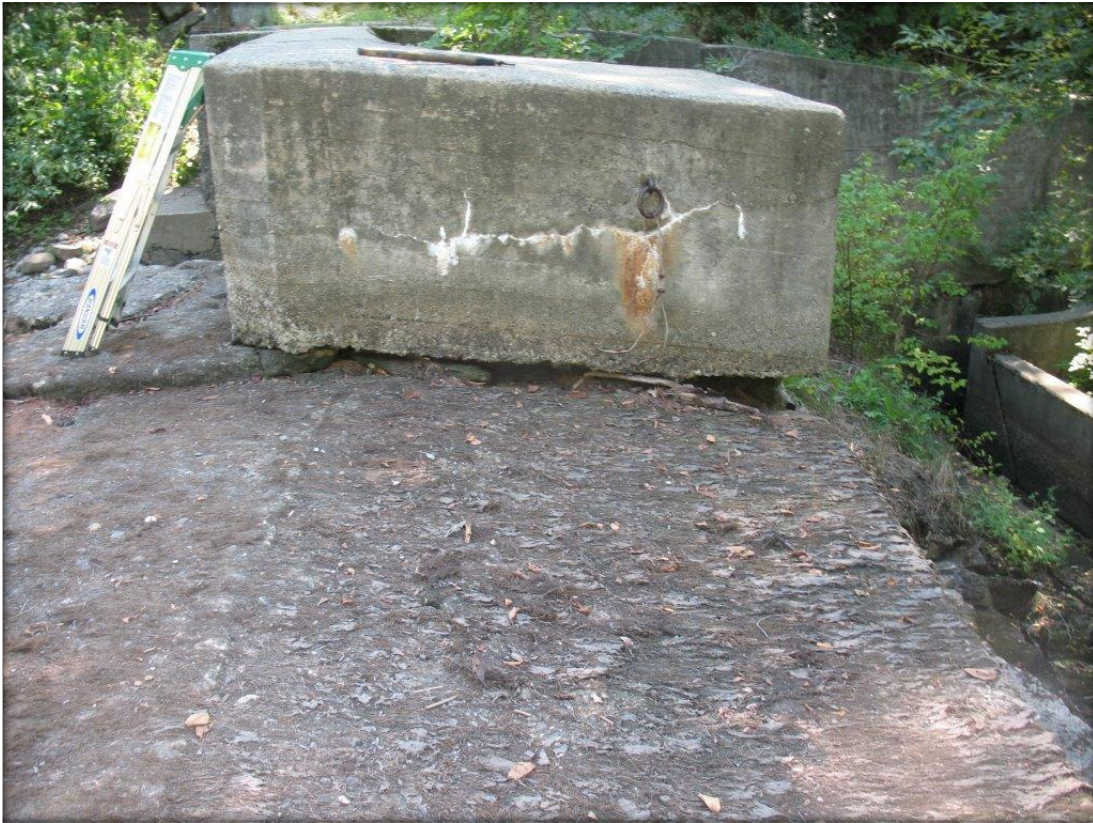
The left spillway pier experienced significant deterioration (Photos 3, 5-7). The pier was eroded and undermined on the upstream side and along the spillway crest creating a continuous void, 4 to 6 inches high and 6 to 12 inches deep, causing exposure of the interior rubble. The void continues further to the downstream pier side increasing in size and extent, up to 3 feet high, 3 feet long, and 1 foot deep (Photo 6). This void, connected to the spillway, could redirect a significant amount of the spillway flow to the unprotected downstream masonry. Several missing large stones were observed at that area. The pier landside contained even a larger void estimated at 3.5 feet high, 3.5 feet long, and 1 to 2 feet deep (Photo 7). The pier was a massive structure (7 feet long, 6-7 feet wide, 4-5 feet high) and appeared stable despite loss of significant amount of masonry. A crack at the corner of the pier with the left nonoverflow was observed and judged to be old.

Photo 5. Left Spillway Pier Undermined Base.

The deeply deteriorated downstream face of the left nonoverflow structure would be repaired by installation of a concrete overlay similar to the upstream face overlay and large cavities in the masonry would be filled with reinforced concrete. The severely deteriorated 7-foot wide left spillway pier which appeared marginally stable would be replaced with a 2-foot thick concrete pier re-connected to the left nonoverflow with a concrete wall. The pier base masonry would be

replaced with a reinforced concrete slab. The details of this repair are shown in Sections 3-5 included in Attachment C.

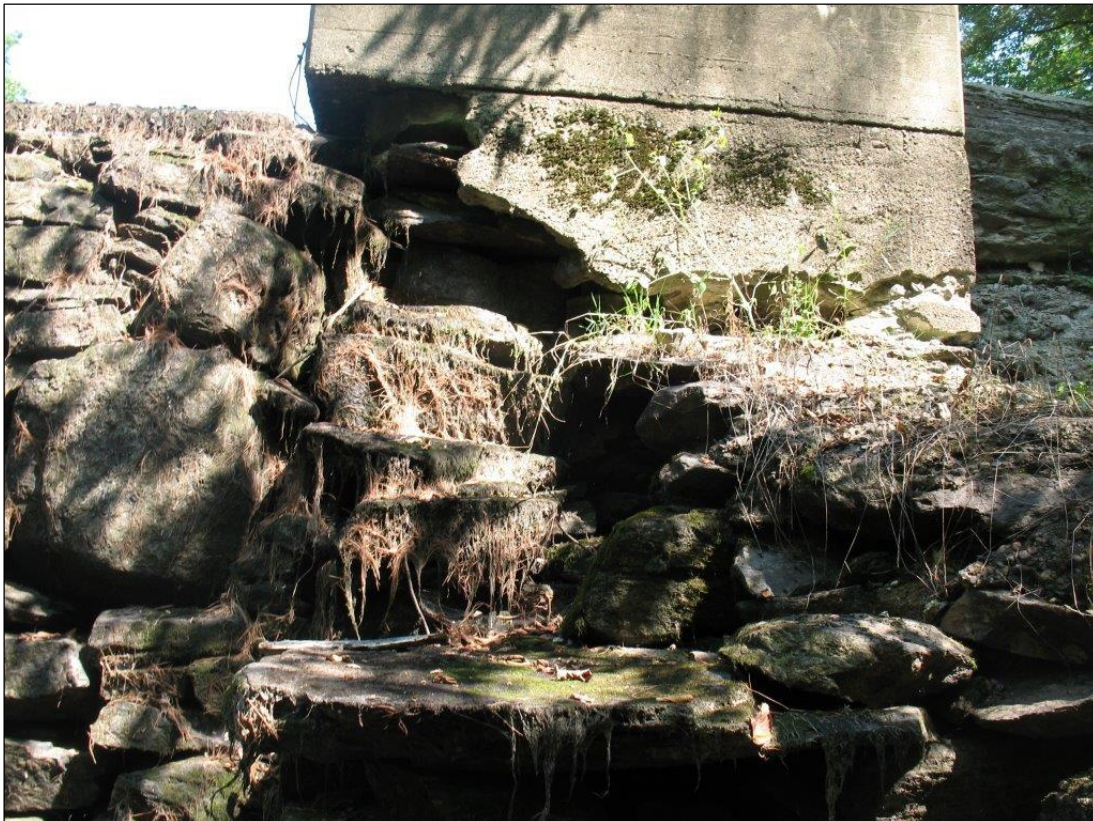
Photo 6. Downstream Face of Left Spillway Pier: Cavity and Base Undermining.

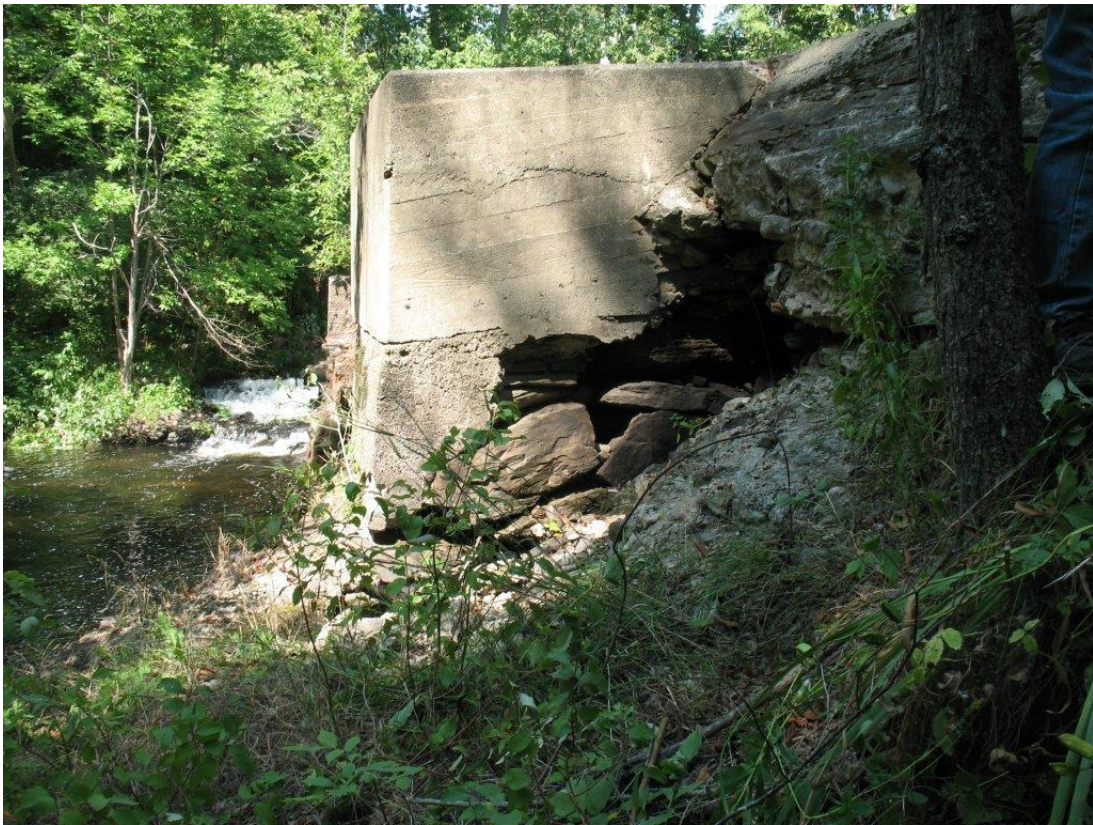
Photo 7. Left Spillway Pier Landside Large Cavity.

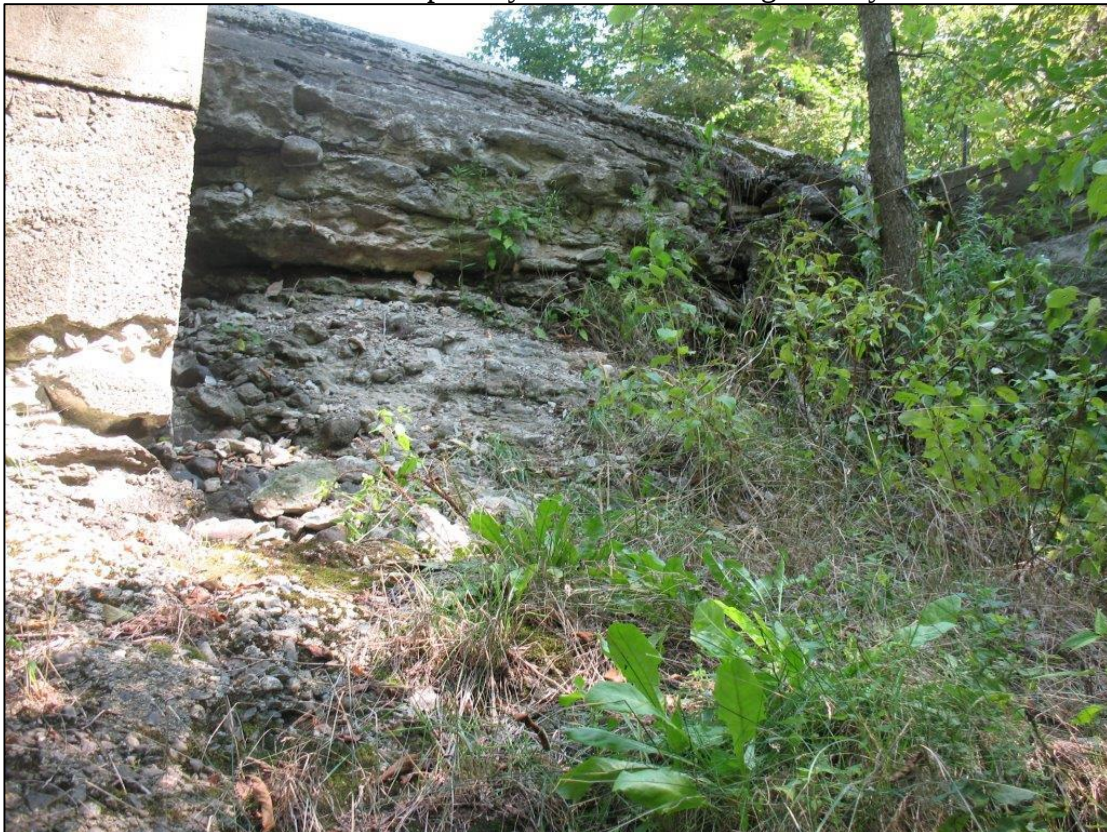
Photo 8. Left Nonoverflow: Deteriorated Downstream Face and Backfill. Note Vegetation and Large Tree.

5. Trees and brush causing loosening and dislocation of the masonry in the left and right nonoverflow structures by root penetration should be cut and removed within 10-20 feet of the dam.

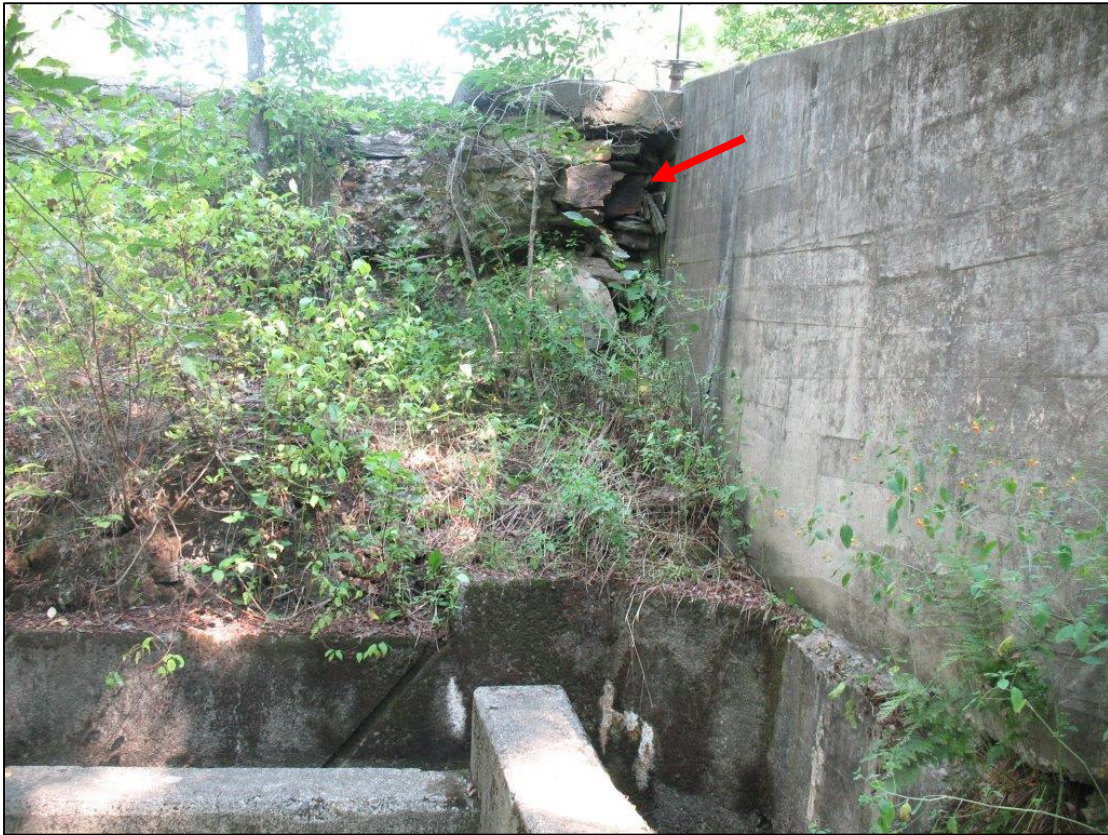
Photo 9. Left Nonoverflow: Large Cavity in Masonry Block Adjacent to Fishway (Arrow).

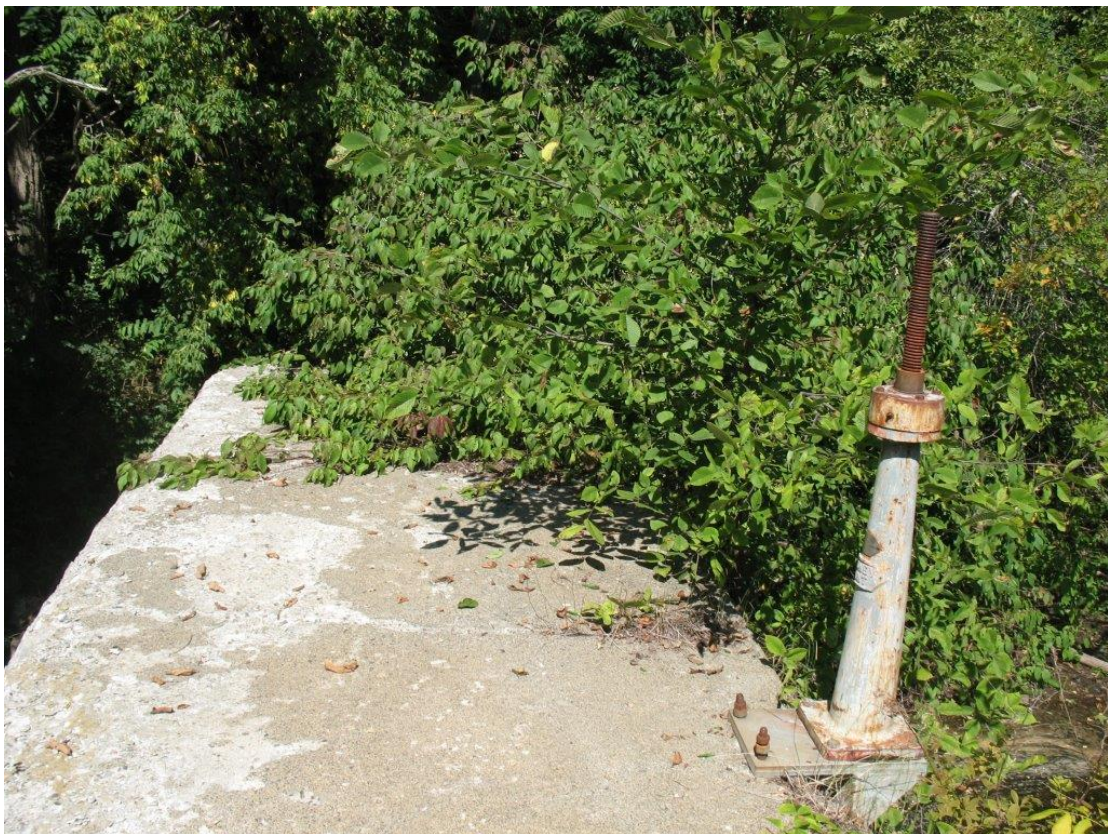
Photo 10. Top of Right Nonoverflow at Right Outlet Gate Operator: Note Heavy Overgrowth.

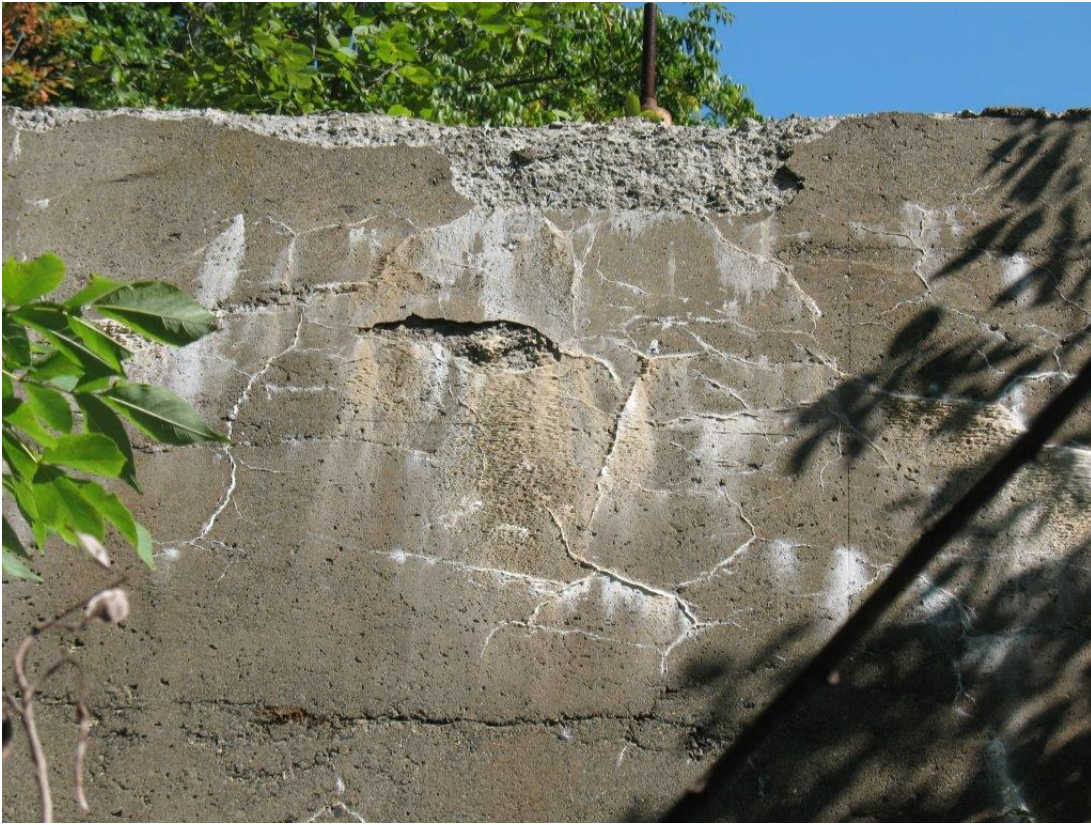
Photo 11. Right Nonoverflow Structure: Upstream Face Concrete Spalling and Deterioration.

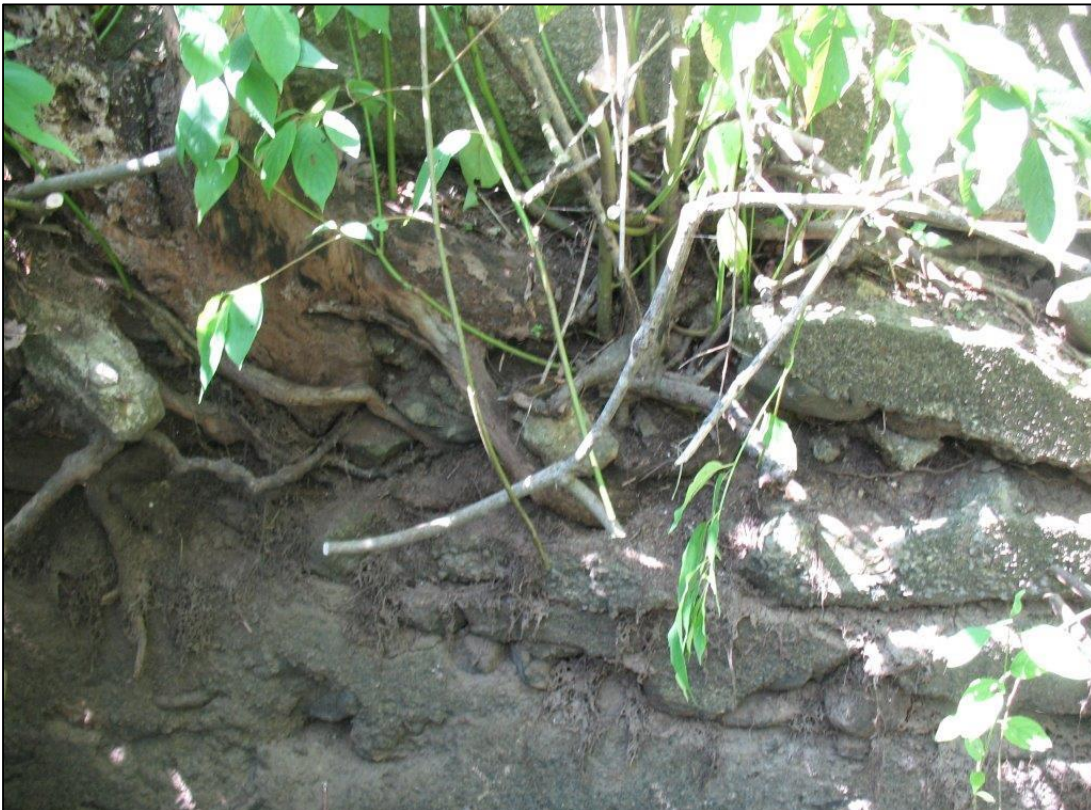
Photo 12. Right Nonoverflow Upstream Face: Masonry Rubble Uplifted by Vegetative Roots.

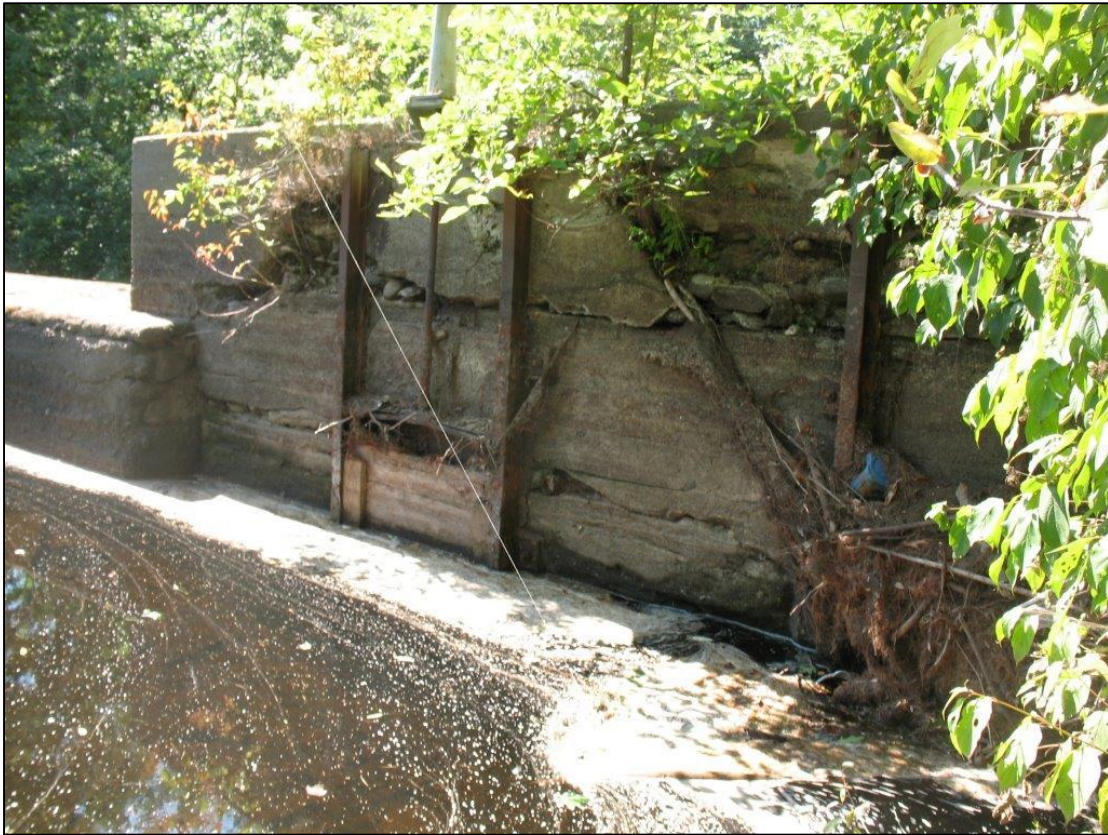
The right nonoverflow appeared in stable condition with no signs of movement observed. The wall was heavily overgrown with trees and brush obstructing the inspection. The top of the structure was weathered and slightly eroded at the edges and judged to be in fair condition (Photo 10). The upstream face showed significant deterioration and spalling of the concrete cover (Photo 11), penetration of tree roots causing lifting, dislocation and degradation of the masonry (Photo 12), and development of deep voids with exposure of the interior rubble (Photo 13). The

The timber gates installed to regulate the outlet flow were permanently lowered and inoperable (Photo 13). The interior of the outlets was observed using a flashlight. It appears that the original outlets were about 3 feet by 3 feet, 10-foot long masonry conduits later equipped later with 36-inch diameter corrugated metal pipe (CMP) culverts. The culverts extended about 5 feet inside of the masonry conduits from the downstream leaving the upstream portion of the conduit unlined. The exposed outlet masonry appeared dry and intact. The timber gates were leaking extensively between timber boards and around their perimeter (Photos 14, 16). The depth of flow exiting each culvert (Photos 15, 17) was measured and the discharge assessed using the U.S. Bureau of Reclamation's methodology<sup>4</sup>. The flow from the left and right culverts was determined to be 2 cfs<sup>5</sup> and 8 cfs, respectively, with the combining discharge from the conduits about 10 cfs.

Photo 13. Right Nonoverflow: Left Outlet Timber Gate and Deteriorated Upstream Face.

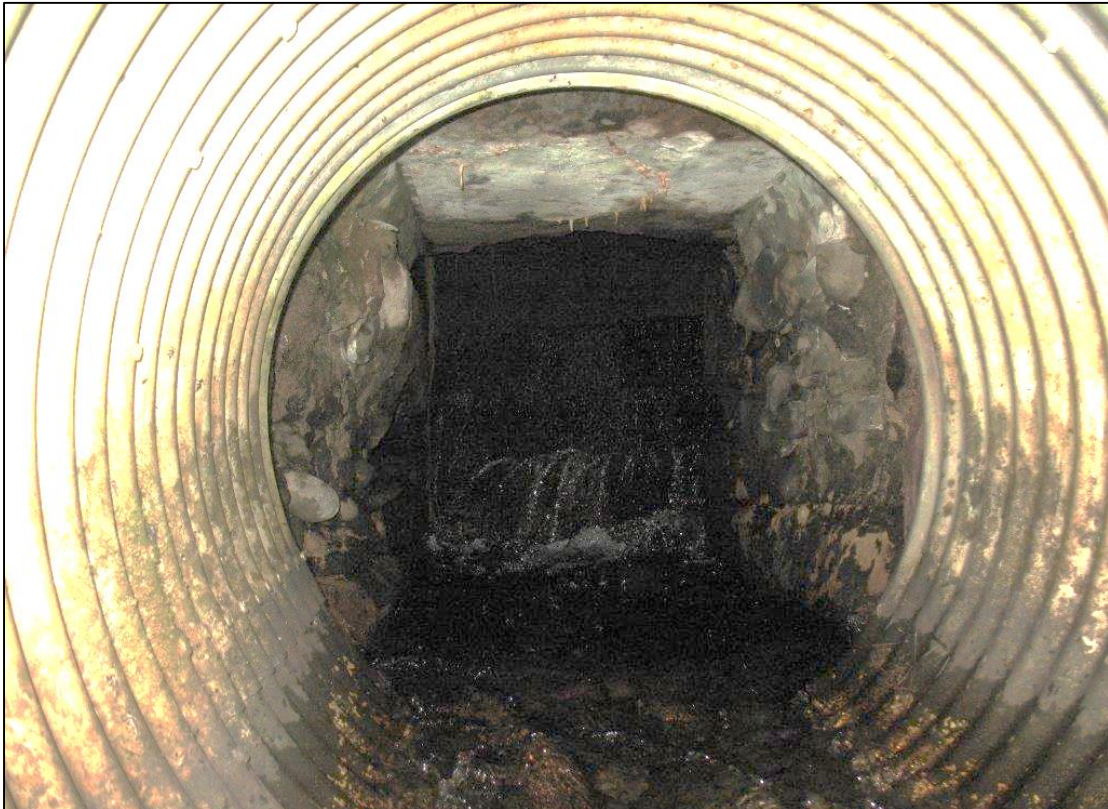
Photo 14. Leaking Gate of Left Outlet.

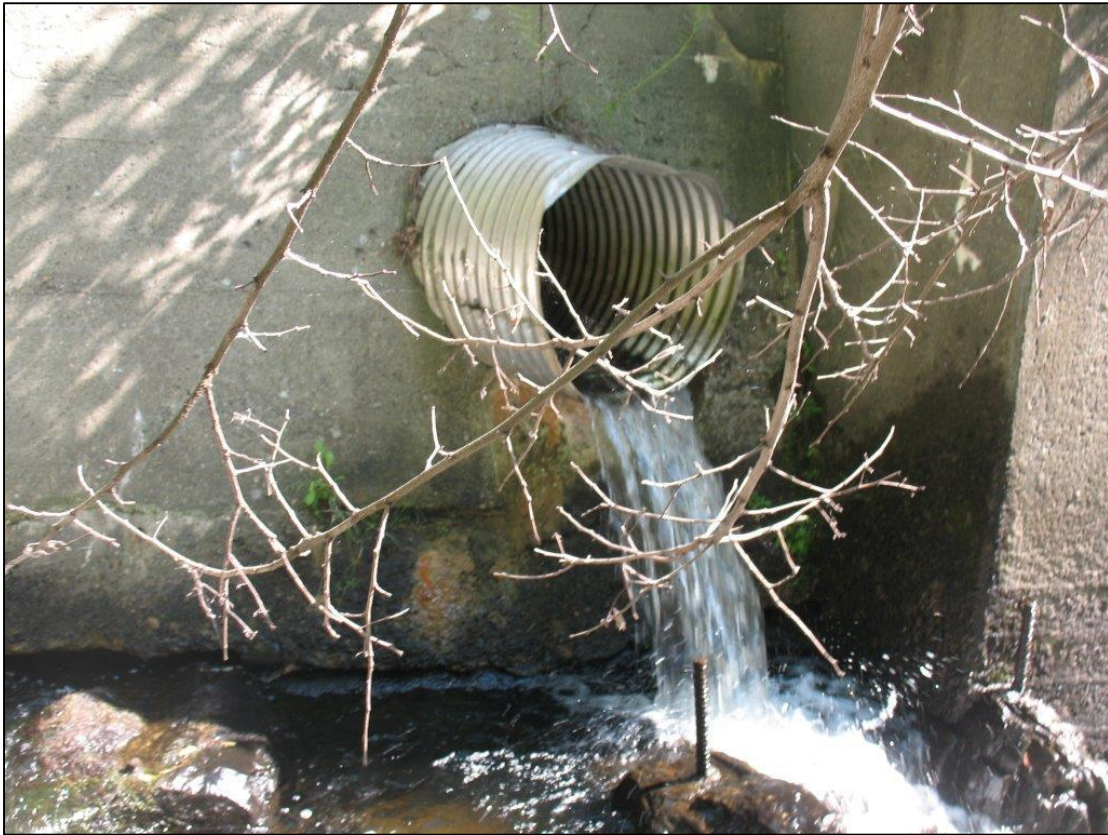
Photo 15. Leakage Discharge from Left Outlet Culvert.

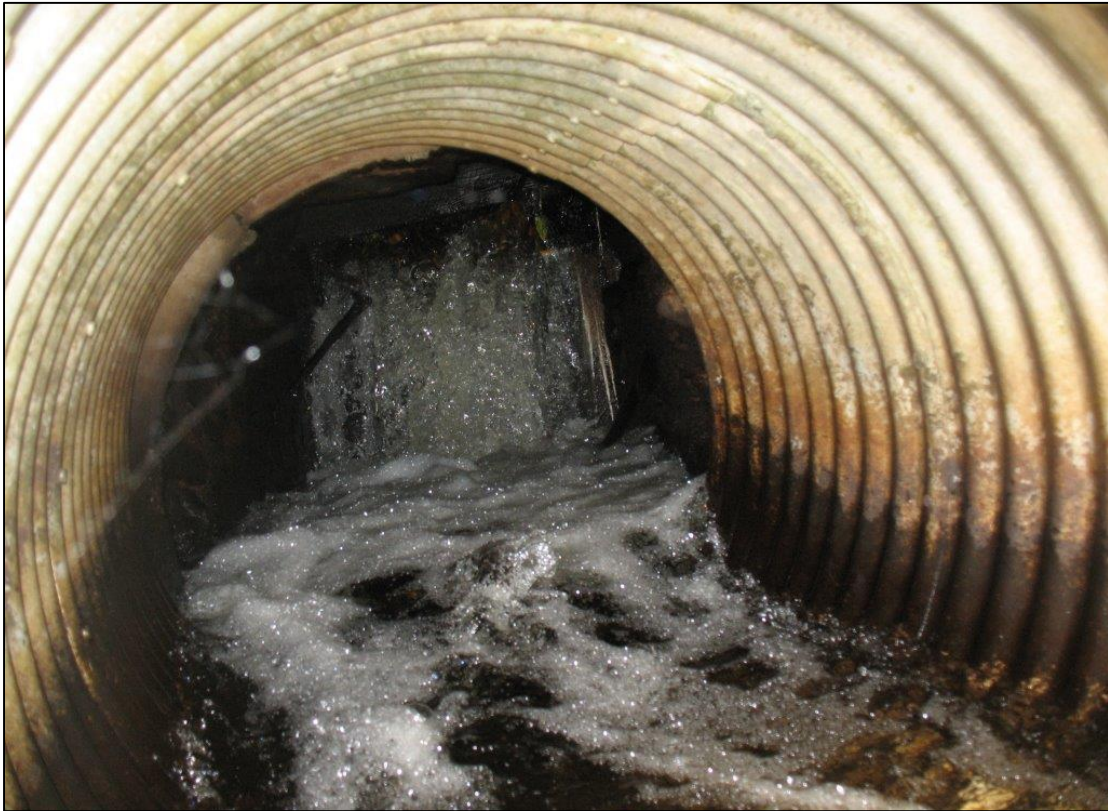
Photo 16. Leaking Gate of Right Outlet.

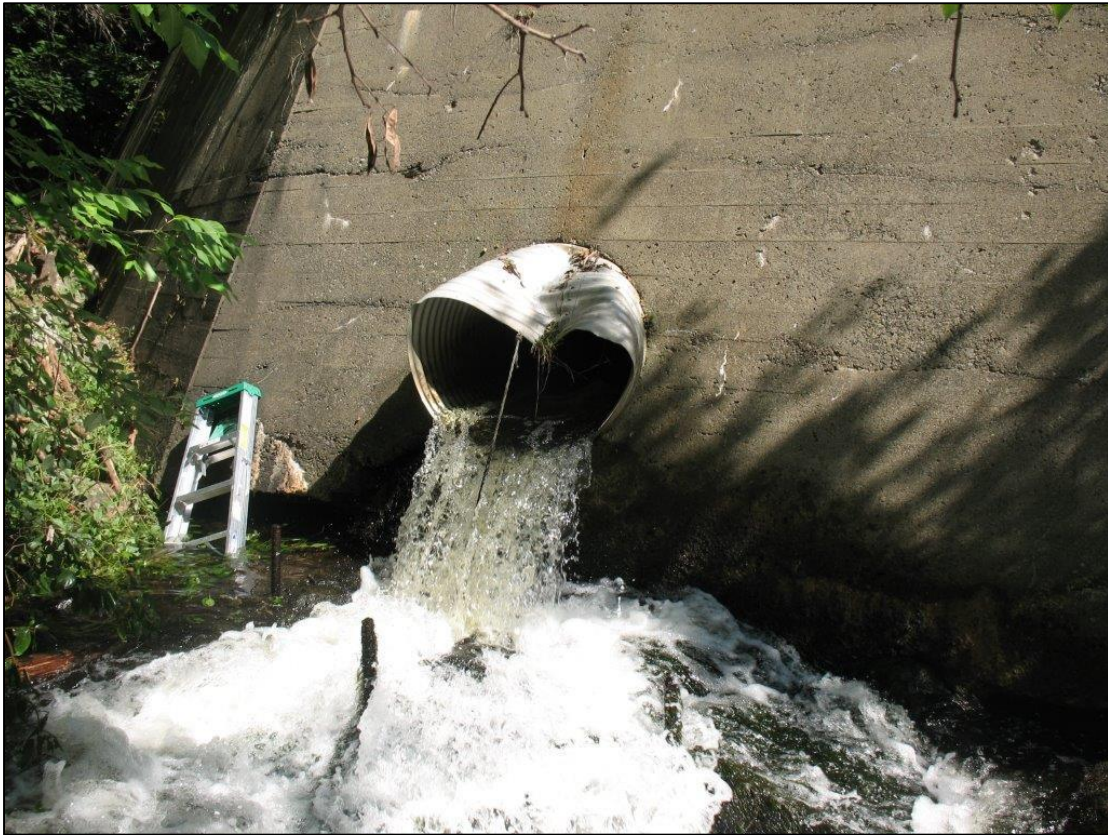
Photo 17. Leakage Discharge from Right Outlet Culvert.

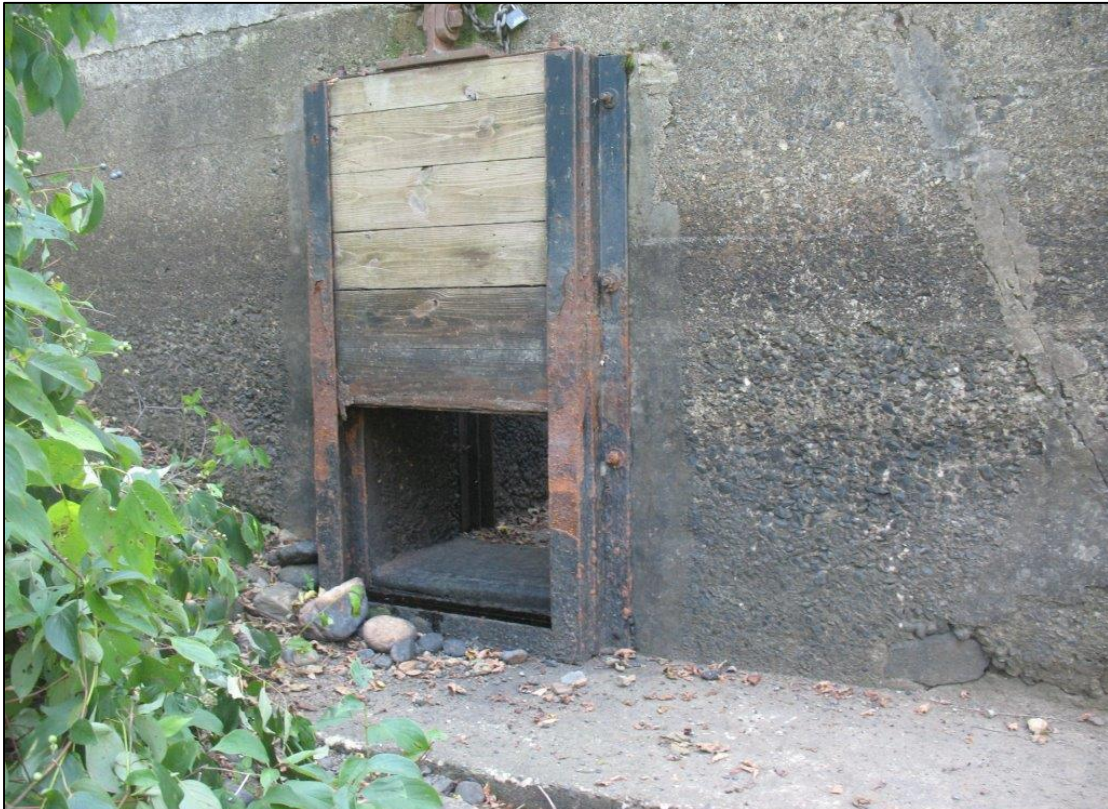
Photo 18. Exposed Upstream Opening and Timber Gate of Fishway.
