# **COOPERS MILLS DAM, WHITEFIELD, MAINE**

## **CONCEPTUAL REPAIR DESIGN**

**December 2015**

Subject: Conceptual Repair Design for Coopers Mills Dam, Whitefield, Maine

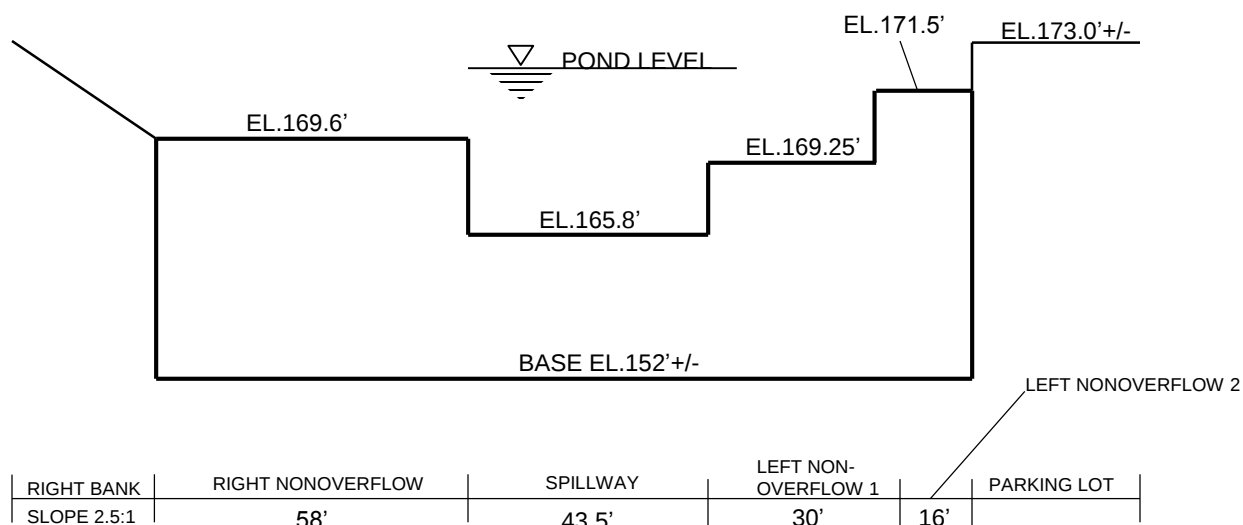
Figure 1. Schematic Elevation of Coopers Mills Dam.

The spillway discharge was determined using a standard weir equation where variables include a spillway length, discharge coefficient (a measure of hydraulic efficiency) and hydraulic head. The discharge coefficient for the broad-crested weir was obtained from the King's "Handbook of Hydraulics" (1976). The discharge was calculated for each structure affected by overtopping including nonoverflow structures and abutments. The maximum capacity of the existing spillway was determined when the pond level is at the lowest point of the dam which is the left nonoverflow structure 1 with the crest elevation 169.25 feet. Subsequently, the dam discharge was determined for the pond level at the top of the right nonoverflow (elevation 169.6 feet), left nonoverflow 2 (elevation 171.5 feet), and left abutment parking lot at Basin Lane (elevation 173.0 feet). The pond level was also determined for each flood with the recurrence intervals from the 2-year and up to the 100-year (Table 2). A schematic sketch of the dam in Figure 1 shows elevations and dimensions of each structure considered in the analysis. The results of the hydraulic calculations for each structure including the pond stage, discharges, overtopping head, and corresponding flood recurrence intervals are summarized in Table 3.

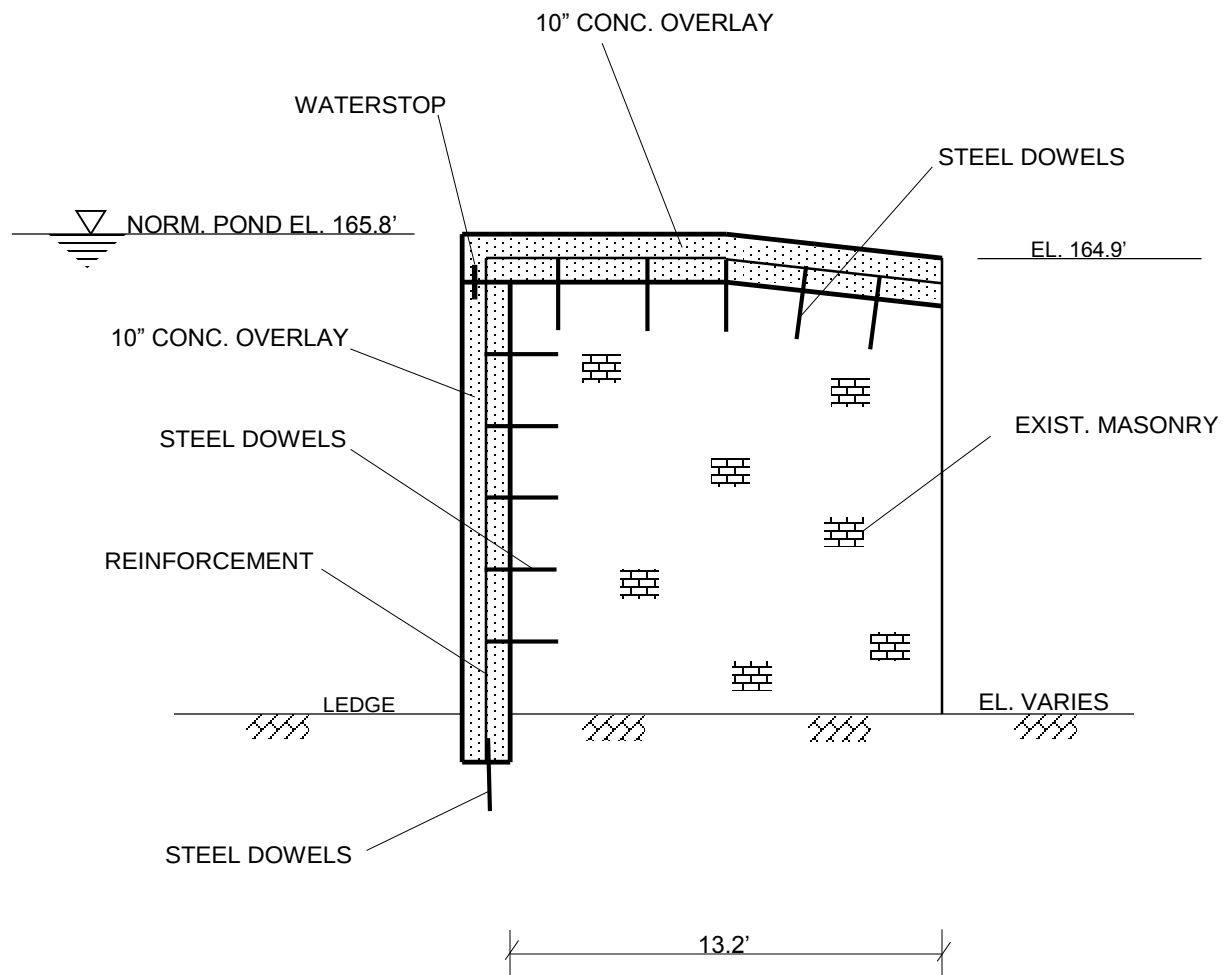
**SECTION 1**  
**SPILLWAY OVERLAY**  
NOT TO SCALE

The concreted spillway crest was weathered exposing coarse aggregate (Photo 1). The upstream edge of the concrete cover, about 4 inches thick, was eroded through at some places. A flat area extending to the left of the spillway crest contained a large cavity, 2 feet by 1.5 feet by 1 foot deep,

providing a direct entry of the pond water to the masonry interior (Photo 2). It is possible the cavity was formed by the impact from moving heavy logs observed hanging on the spillway during our site visit in 2007. About 4 feet of the upstream spillway face above the pond level available for observation experienced significant deterioration resulting in a loss of about 50 to 70 percent of the concrete cover, missing stone, and development of voids (Photo 3). A large cavity, about 20 feet long, 1 foot high, and up to 12 inches deep was observed under spillway crest concrete overlay (Photo 3). The cavity reduces a bearing support for the concrete cover and provides a potential seepage entry into the structure. The downstream face of the spillway composed of angled, mostly elongated rocks appeared stable and dry for the most part. Leakage emerging from the spillway downstream face at the level about 1.5 feet above the tailwater was confined between the exposed ledge<sup>3</sup> and left spillway corner and then continued along the masonry placed between the spillway and fishway (Photo 4). A leakage discharge at this area was estimated about 10 cubic feet per second (cfs). Some foam circulation indicating presence of considerable leakage was also observed immediately to the right of the exposed ledge.

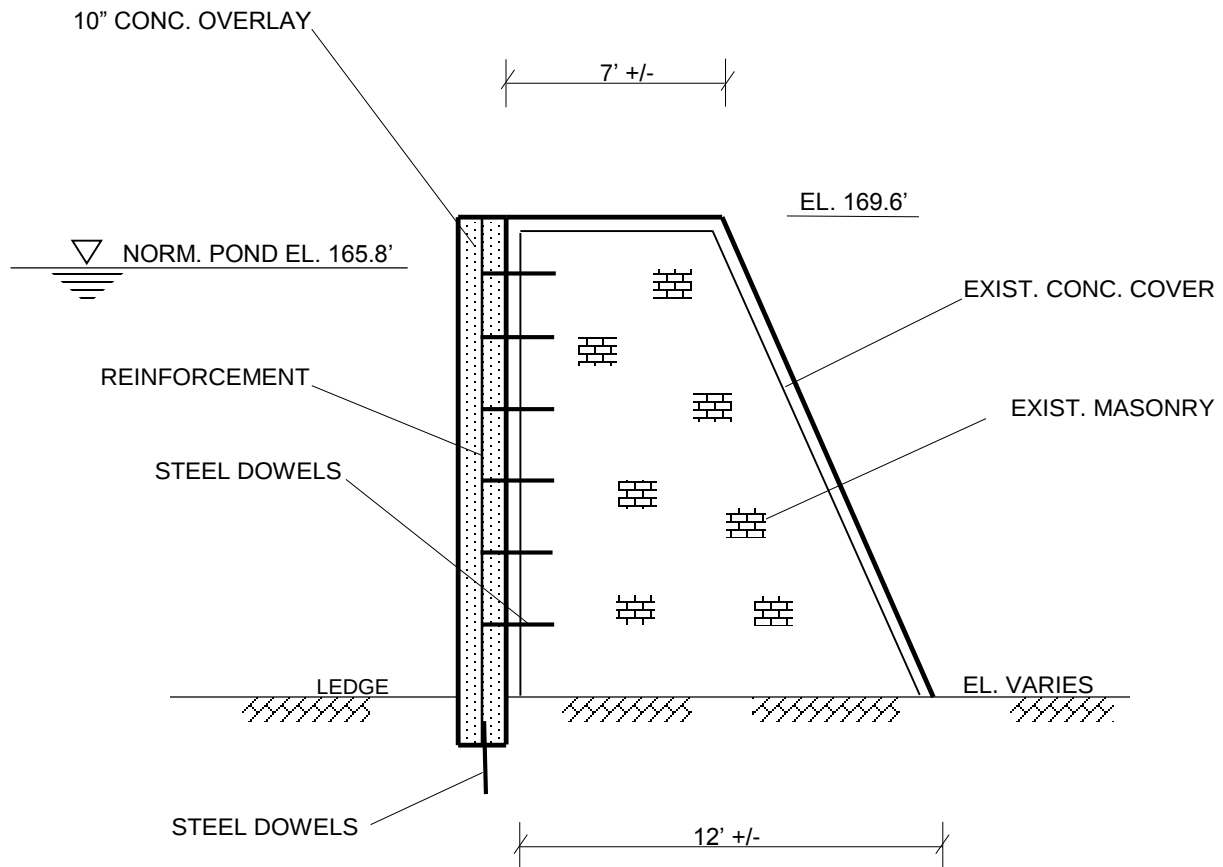
**SECTION 2**  
**RIGHT NONOVERFLOW**  
NOT TO SCALE

The right nonoverflow appeared in stable condition with no signs of movement observed. The wall was heavily overgrown with trees and brush obstructing the inspection. The top of the structure was weathered and slightly eroded at the edges and judged to be in fair condition (Photo 10). The upstream face showed significant deterioration and spalling of the concrete cover (Photo 11), penetration of tree roots causing lifting, dislocation and degradation of the masonry (Photo 12), and development of deep voids with exposure of the interior rubble (Photo 13). The

downstream face concrete was in adequate condition. No signs of significant seepage through or at the toe of the structure were noticed.

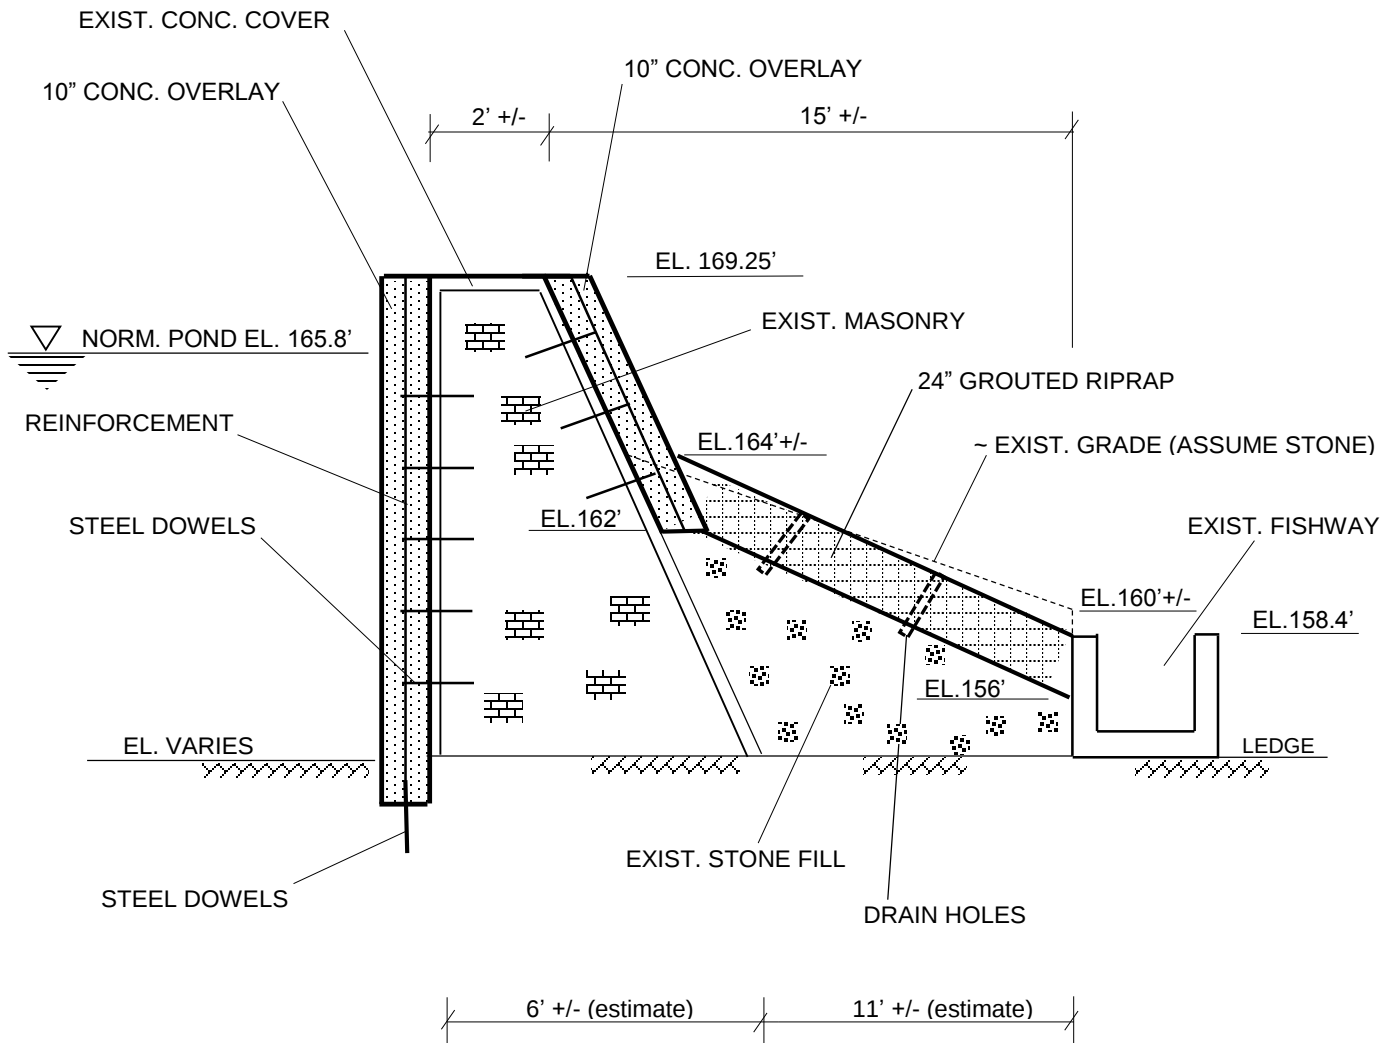
**SECTION 3**  
**LEFT NONOVERFLOW**  
NOT TO SCALE

The structure significantly deteriorated over the years but appeared stable. The top of the nonoverflow was in reasonable condition. The upstream face concrete developed a couple of large diagonal cracks (Photo 3). The cracks were moderately eroded and tight. Two large voids and a loss of the concrete cover were observed on the vertical surface of the structure adjacent to the spillway and nonoverflow (Photo 3). The downstream face of the nonoverflow was significantly deteriorated and undermined showing missing masonry, eroded cement grout and significant amount of voids (Photo 8). The downstream fill consisting essentially of cemented gravel, cobbles and rocks was eroded exposing rugged surface likely caused by overtopping. The area was vegetated and contained a large tree growing close to the structure. A massive block adjacent to the fishway and left nonoverflow experienced significant deterioration including missing and displaced masonry and lost concrete cover (Photo 9). The block contained a large cavity, 4 feet high and 2 feet wide, visible on the riverside and downstream faces.

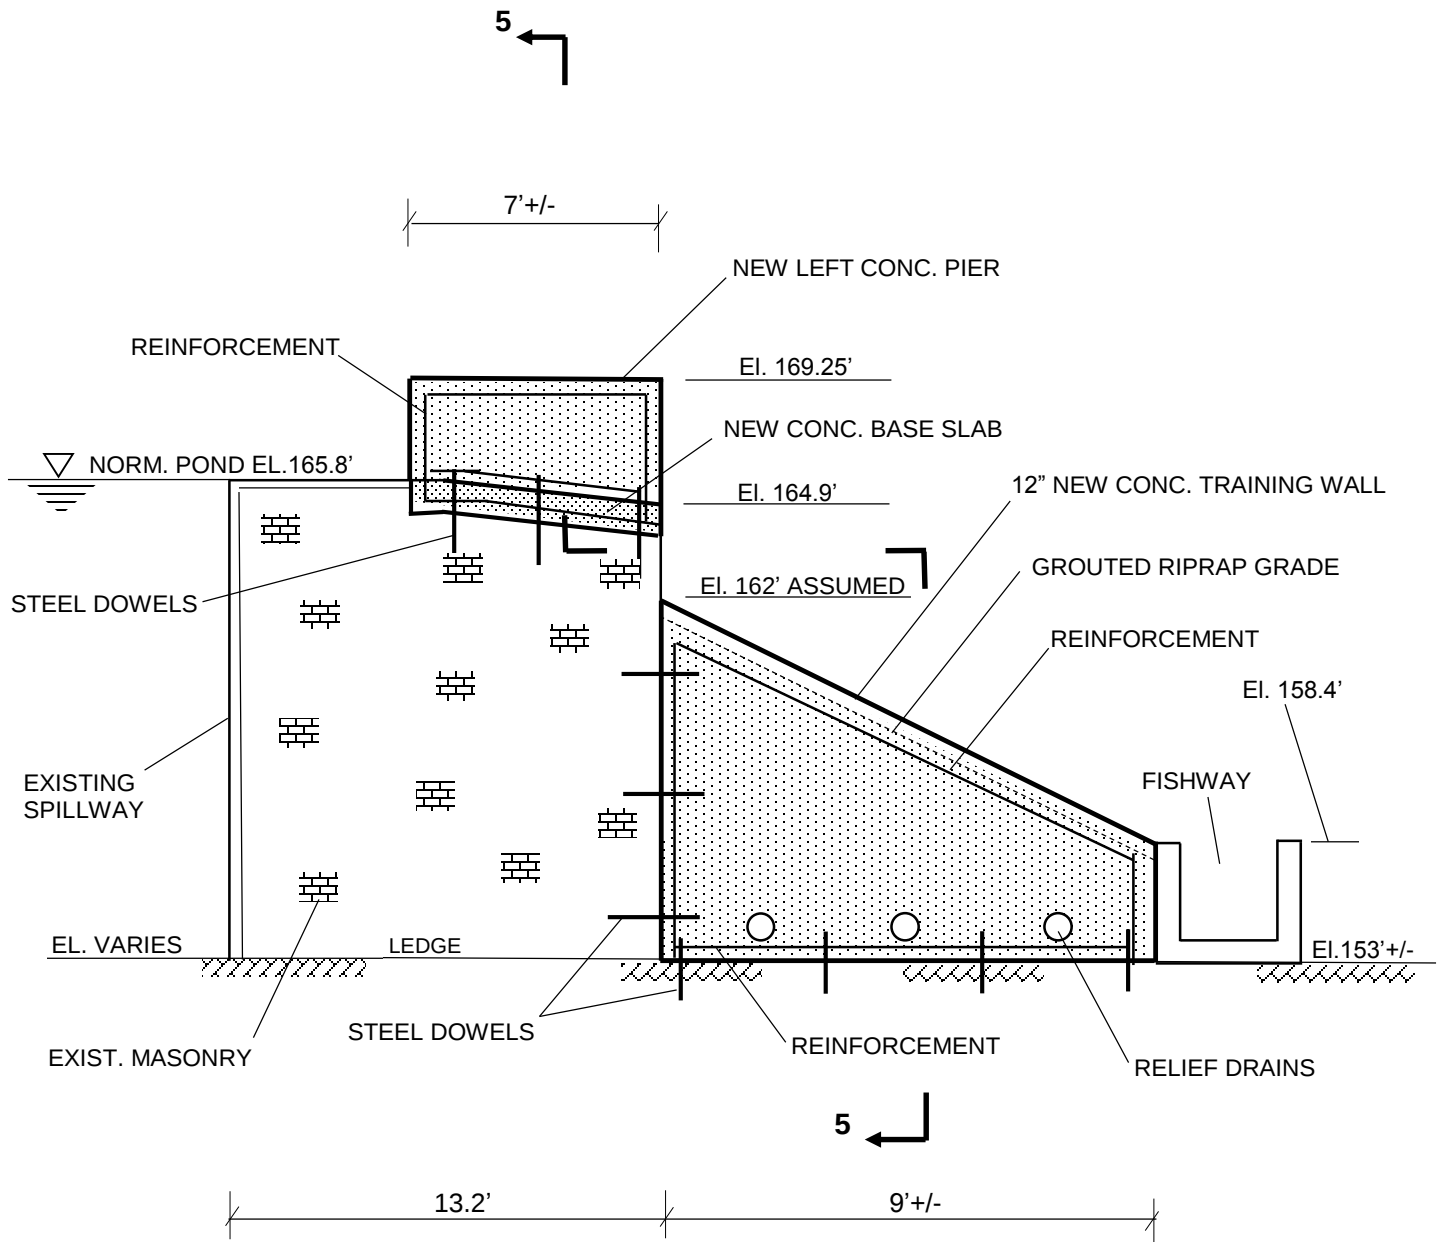
**SECTION 4**  
**LEFT SPILLWAY PIER AND DOWNSTREAM TRAINING WALL**  
NOT TO SCALE

The left spillway pier experienced significant deterioration (Photos 3, 5-7). The pier was eroded and undermined on the upstream side and along the spillway crest creating a continuous void, 4 to 6 inches high and 6 to 12 inches deep, causing exposure of the interior rubble. The void continues further to the downstream pier side increasing in size and extent, up to 3 feet high, 3 feet long, and 1 foot deep (Photo 6). This void, connected to the spillway, could redirect a significant amount of the spillway flow to the unprotected downstream masonry. Several missing large stones were observed at that area. The pier landside contained even a larger void estimated at 3.5 feet high, 3.5 feet long, and 1 to 2 feet deep (Photo 7). The pier was a massive structure (7 feet long, 6-7 feet wide, 4-5 feet high) and appeared stable despite loss of significant amount of masonry. A crack at the corner of the pier with the left nonoverflow was observed and judged to be old.

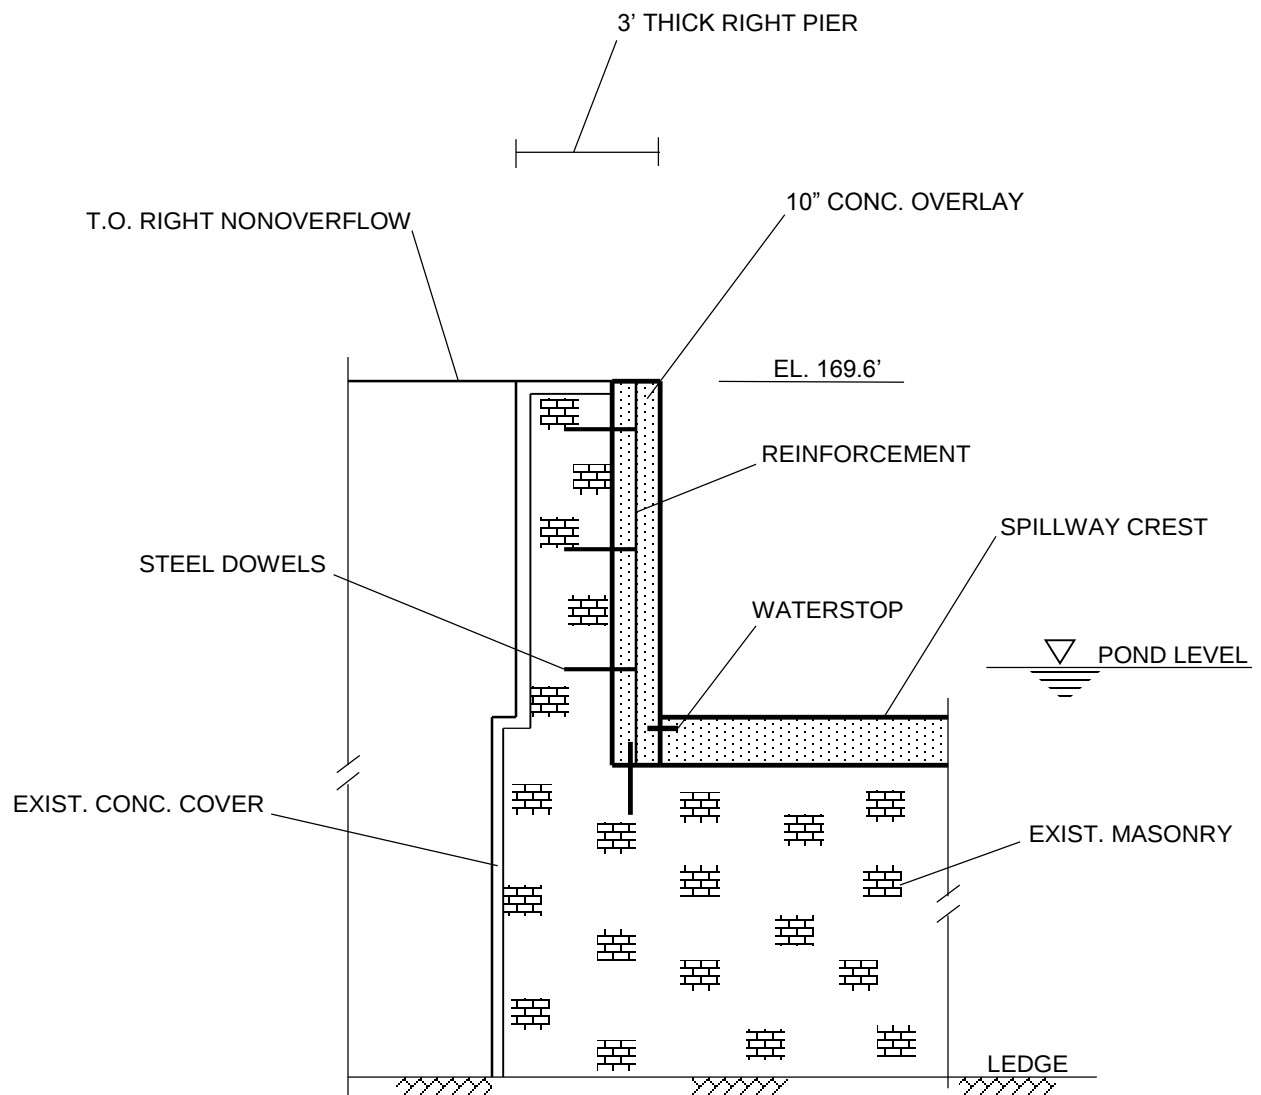
## SECTION 6

The right spillway pier was in adequate and stable condition (Photo 1). A horizontal crack in the concrete cover located about 2 feet above the spillway crest was slightly eroded but appeared tight. The concrete surface below the crack was moderately weathered exposing concrete aggregate. High watermark imprinted on the pier below the crack indicated that the typical high water level in the pond was about 2 feet above the spillway crest.

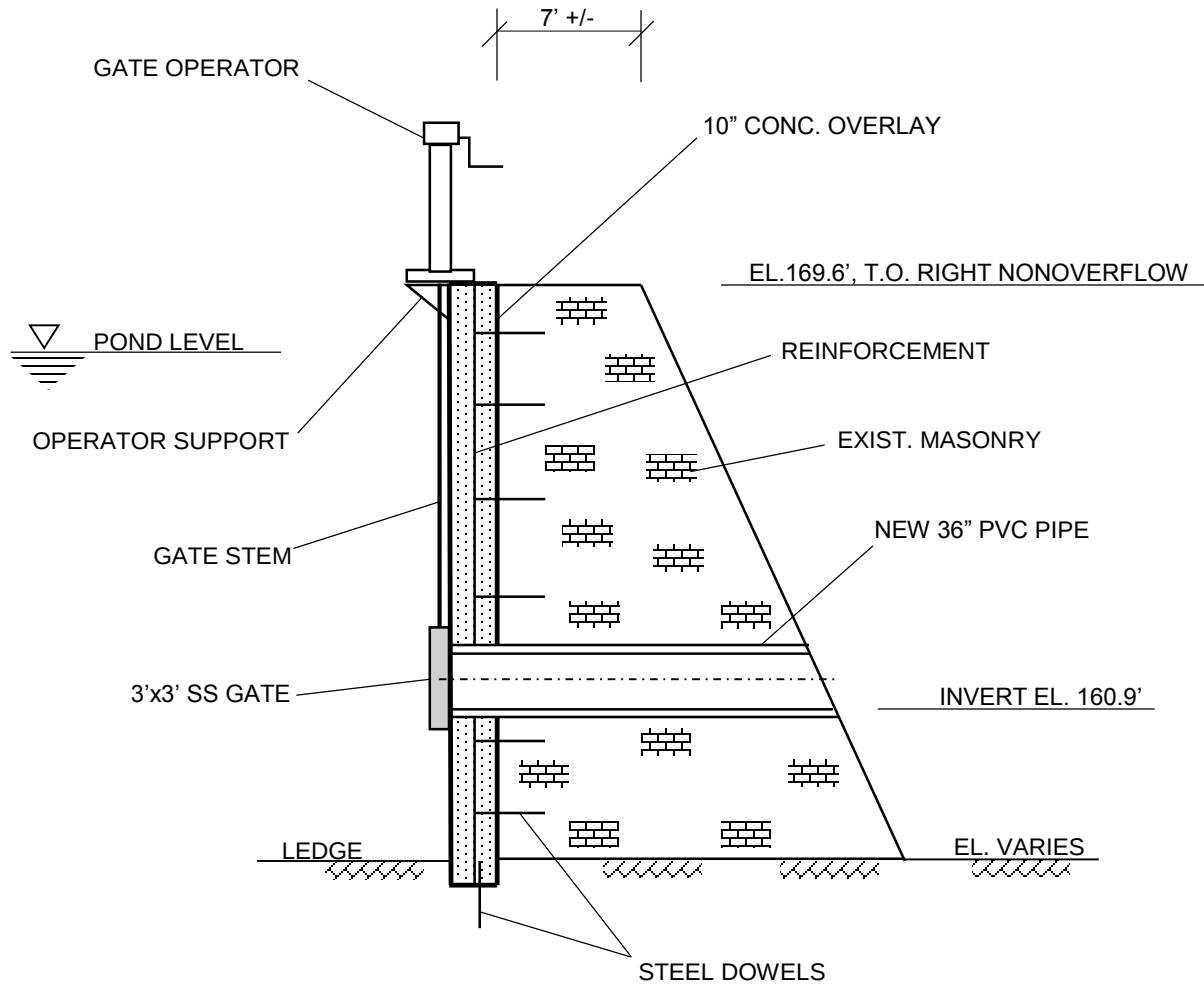
**SECTION 7**  
**GATED OUTLET**  
NOT TO SCALE

The timber gates installed to regulate the outlet flow were permanently lowered and inoperable (Photo 13). The interior of the outlets was observed using a flashlight. It appears that the original outlets were about 3 feet by 3 feet, 10-foot long masonry conduits later equipped later with 36-inch diameter corrugated metal pipe (CMP) culverts. The culverts extended about 5 feet inside of the masonry conduits from the downstream leaving the upstream portion of the conduit unlined. The exposed outlet masonry appeared dry and intact. The timber gates were leaking extensively between timber boards and around their perimeter (Photos 14, 16). The depth of flow exiting each culvert (Photos 15, 17) was measured and the discharge assessed using the U.S. Bureau of Reclamation's methodology<sup>4</sup>. The flow from the left and right culverts was determined to be 2 cfs<sup>5</sup> and 8 cfs, respectively, with the combining discharge from the conduits about 10 cfs.
